Investigation of Controlled Flight into Terrain

U. S. Department
Of Transportation
**Federal Aviation
Administration**

Descriptions of Flight Paths for Selected Controlled Flight into Terrain (CFIT) Aircraft Accidents, 1985-1997

Project Memorandum
DOT-TSC-FA9D1-99-01
March 1999

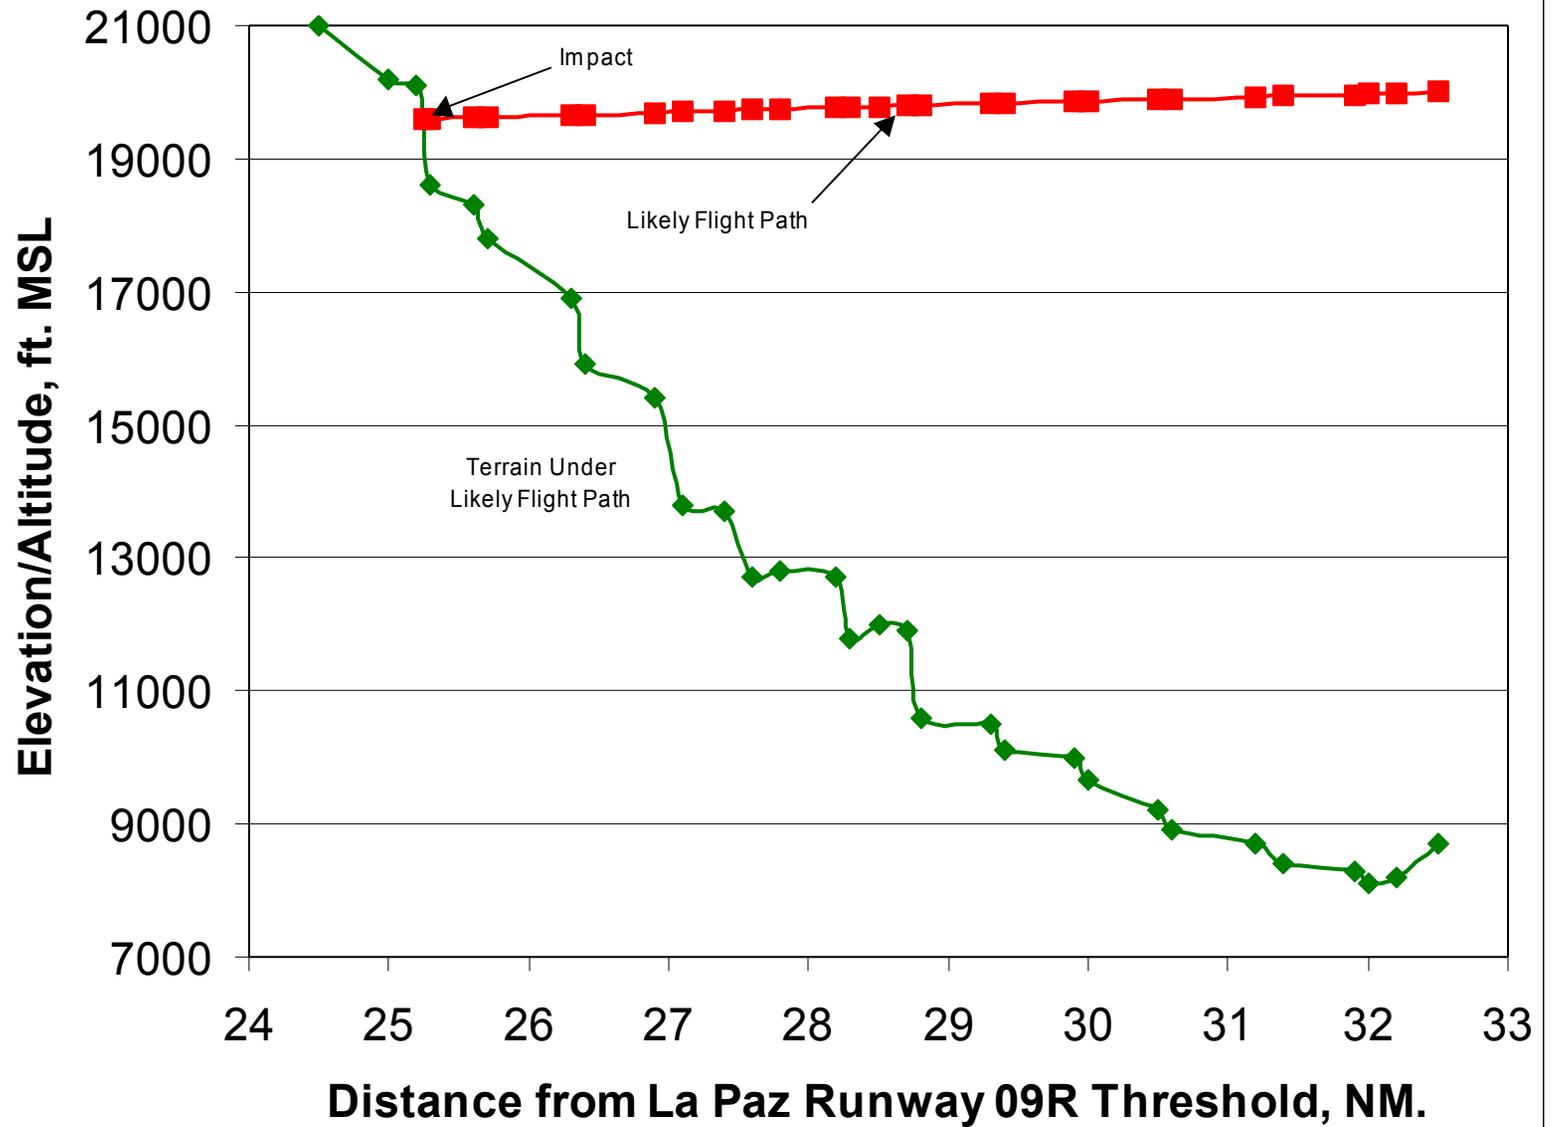
The aircraft had reported crossing the DAKON intersection, 55 NM southeast of La Paz, at 25,000 ft. MSL. They were then cleared by La Paz ATC to descend to 18,000 feet, and the crew acknowledged this clearance. Although the accident aircraft was supposed to be approaching La Paz along airway UA 320, on a 134° radial from the La Paz VOR, it veered significantly off course beyond DAKON; the impact location is along the 106° radial from La Paz. Investigators speculate the flight crew were maneuvering to avoid weather in the vicinity, and that impact occurred with the aircraft in cruise configuration, in a shallow descent. Dark night, weather, and lack of visual references in the area all contributed to the crew's inability to see and avoid the high terrain in their path. (10)

Table 2 presents altitude and elevation information for this accident. This information is presented graphically in Figure 1.

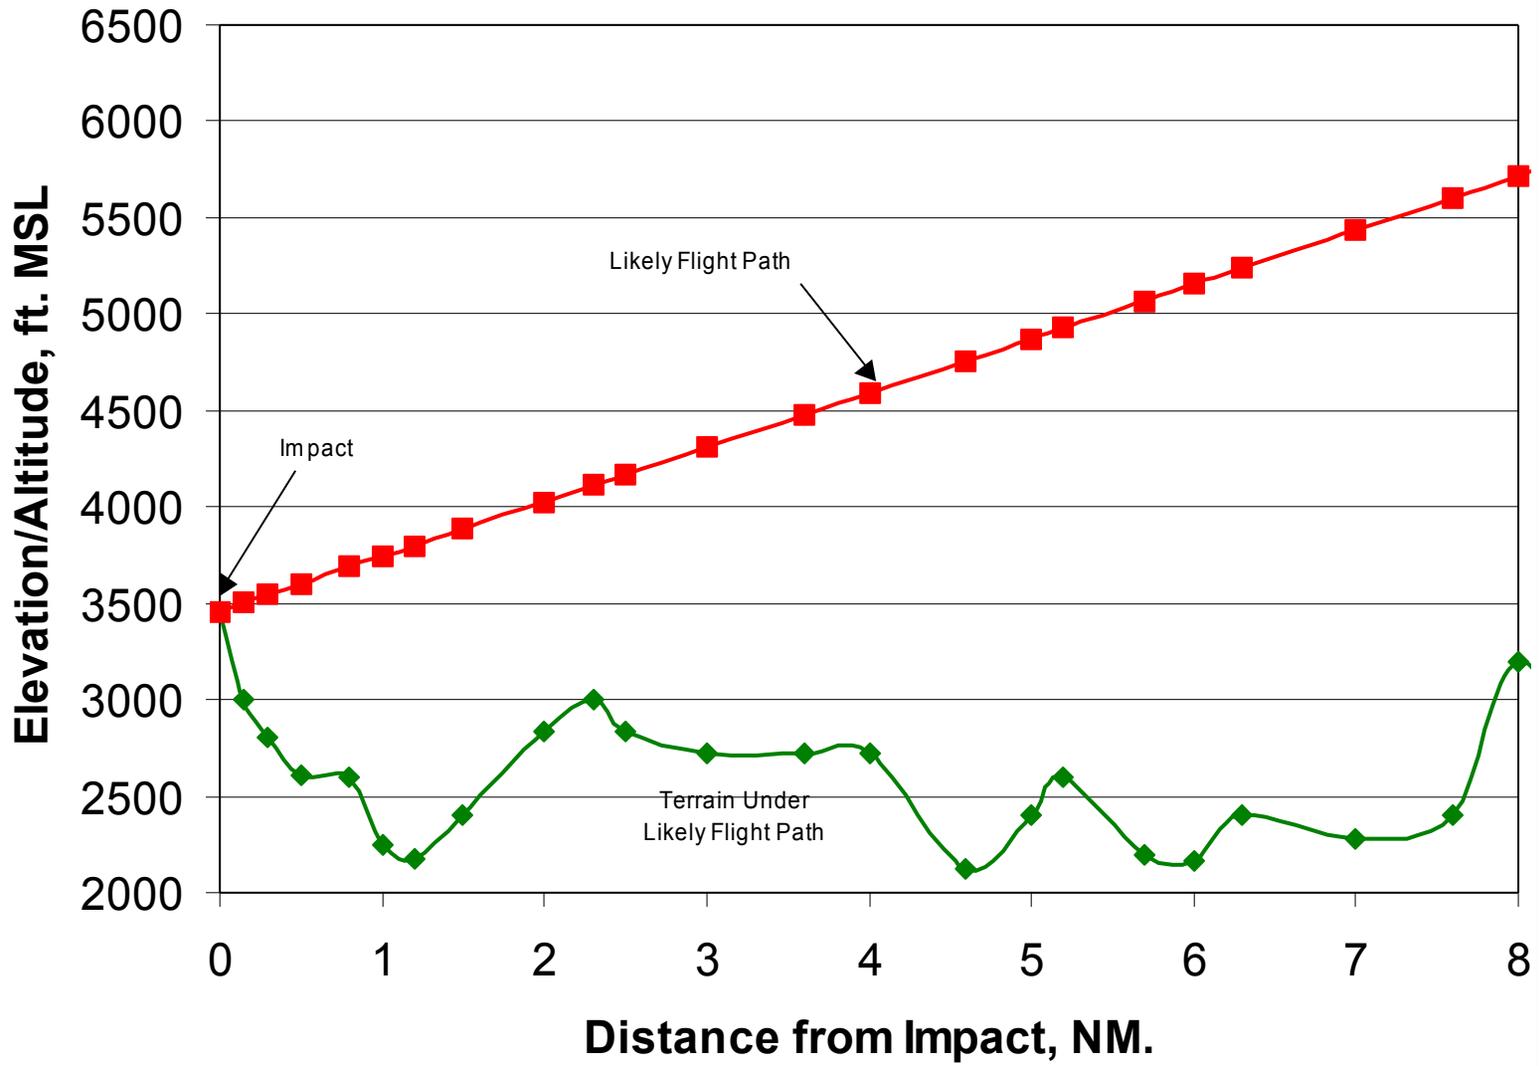
Figure 2.
Flat Rock, NC -- PA-31T -- N600CM -- 8/23/85

A few minutes before the accident, the pilot of N600CM reported to ATC “35 (nautical miles) from the airport, VFR (visual flight rules) for landing.” At the Asheville, NC terminal radar approach control facility, controllers observed the flight in a steady descent from 9700’ to 3600’ in the vicinity of the accident site. The pilot, flying VFR, was just under the cloud ceiling, dangerously close to the uninhabited and unlit mountain peaks in the area. Lacking visual reference, the pilot did not see Stone Mountain until it was too late to react. (12)

N600CM was not equipped with FDR, CVR or GPWS. Table 3 presents altitude and elevation information for this accident. This information is presented graphically in Figure 2.

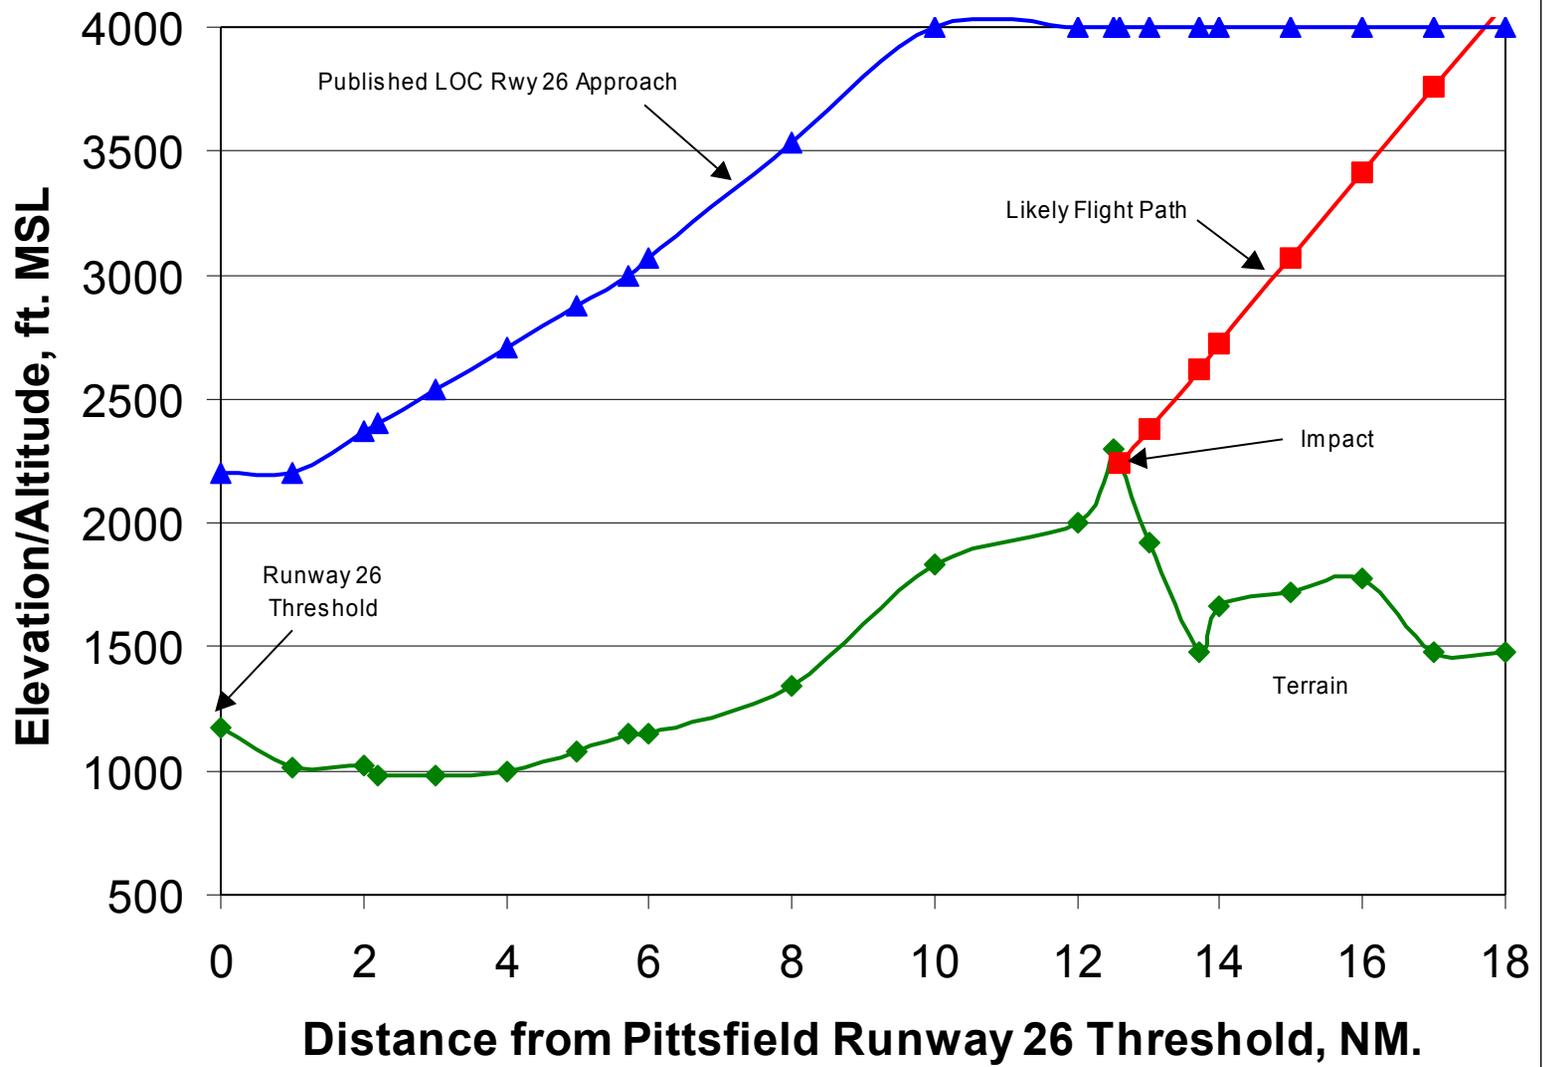
Figure 3.
Windsor, MA -- Be-100 -- N65TD -- 12/10/86

Shortly before the accident, the pilot of N65TD reported “five tango delta, procedure turn inbound Pittsfield,” which indicated the aircraft was beginning its approach. The aircraft apparently began its descent prematurely, deviating well below the published LOC Runway 26 approach procedure. In conditions of very limited visibility, the aircraft descended into the terrain. (13)

N65TD not equipped with FDR, CVR or GPWS. Table 4 presents altitude and elevation information for this accident. This information is presented graphically in Figure 3.

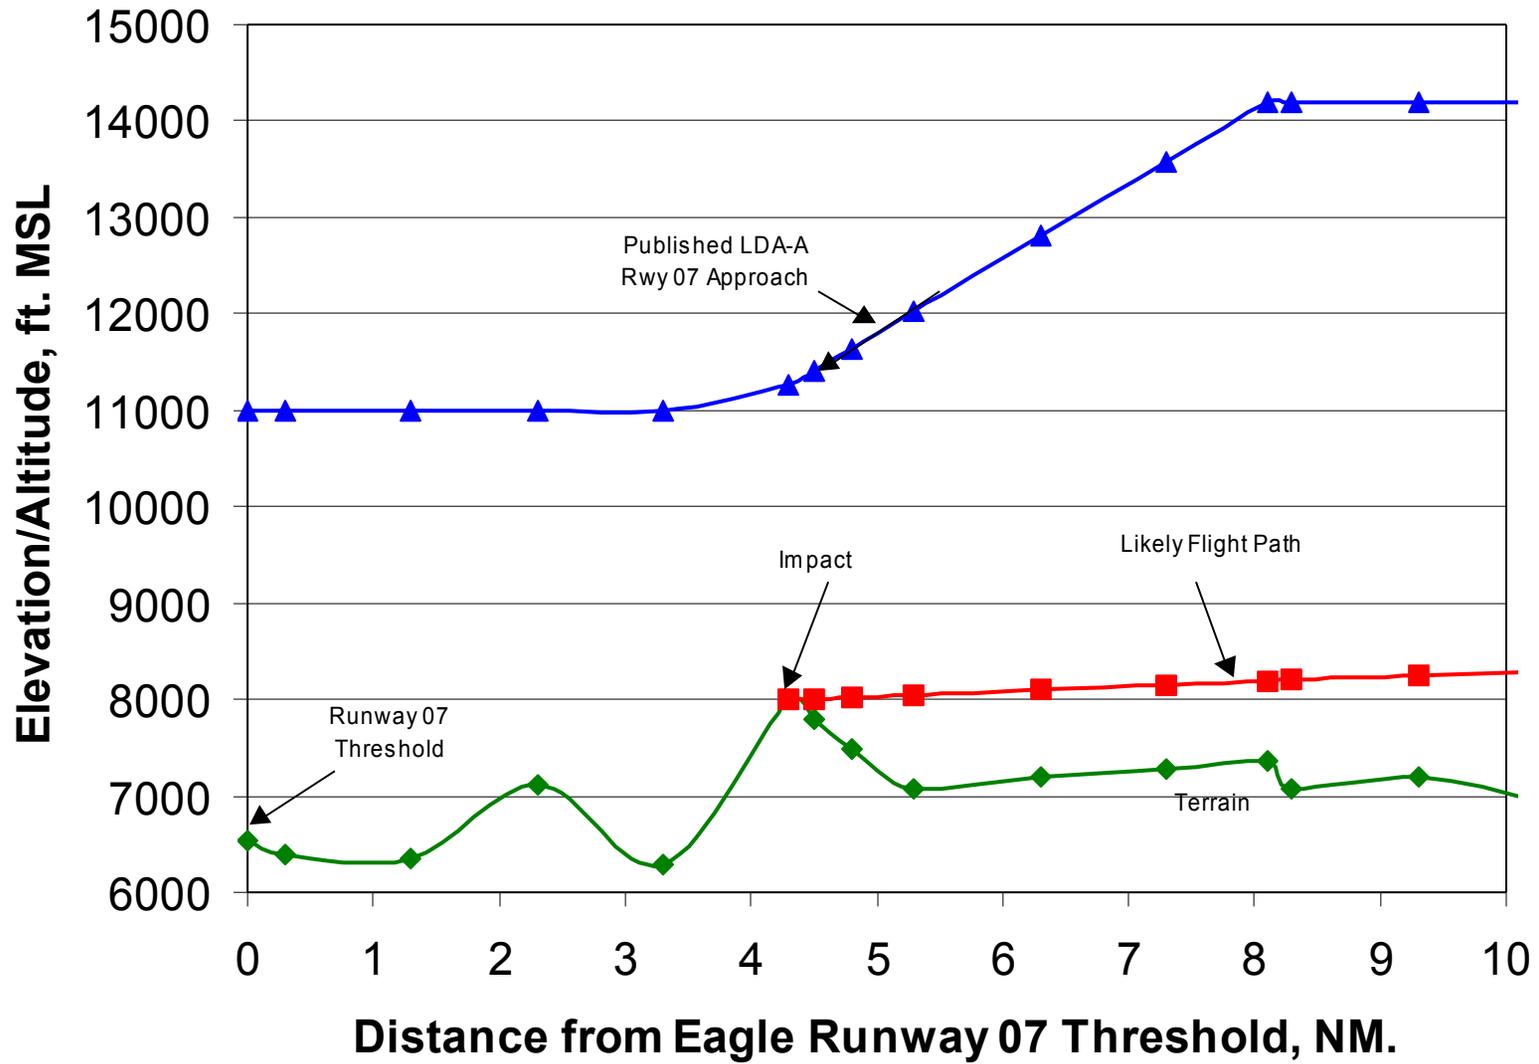
Figure 4.
Eagle, CO -- LJ-24A -- N31SK -- 3/27/87

The pilot of N31SK reported passing the STUPE intersection, and was cleared by ATC for landing at Eagle. Shortly before the accident, the pilot reported "eight to ten miles out, and it's clear to Eagle." From the position and heading of the aircraft at impact, investigators assumed the pilot had elected to fly the circle-to-land LDA-A Runway 07 approach to Eagle. The pilot descended well below the altitudes specified for this approach, but may have done so because he could see the airport. Post-crash investigation showed the pilot would have had the airport in sight for all but the last one to three seconds of flight, when the uninhabited, unlit mountain ridge obstructed his view. Only a very small adjustment to the aircraft's controls would have been required to gain the additional 22' of altitude necessary to clear the ridge. However, lacking visual reference, the pilot was unable to see the terrain until it was too late. (14)

N31SK not equipped with FDR, CVR or GPWS. Table 5 presents altitude and elevation information for this accident. This information is presented graphically in Figure 4.

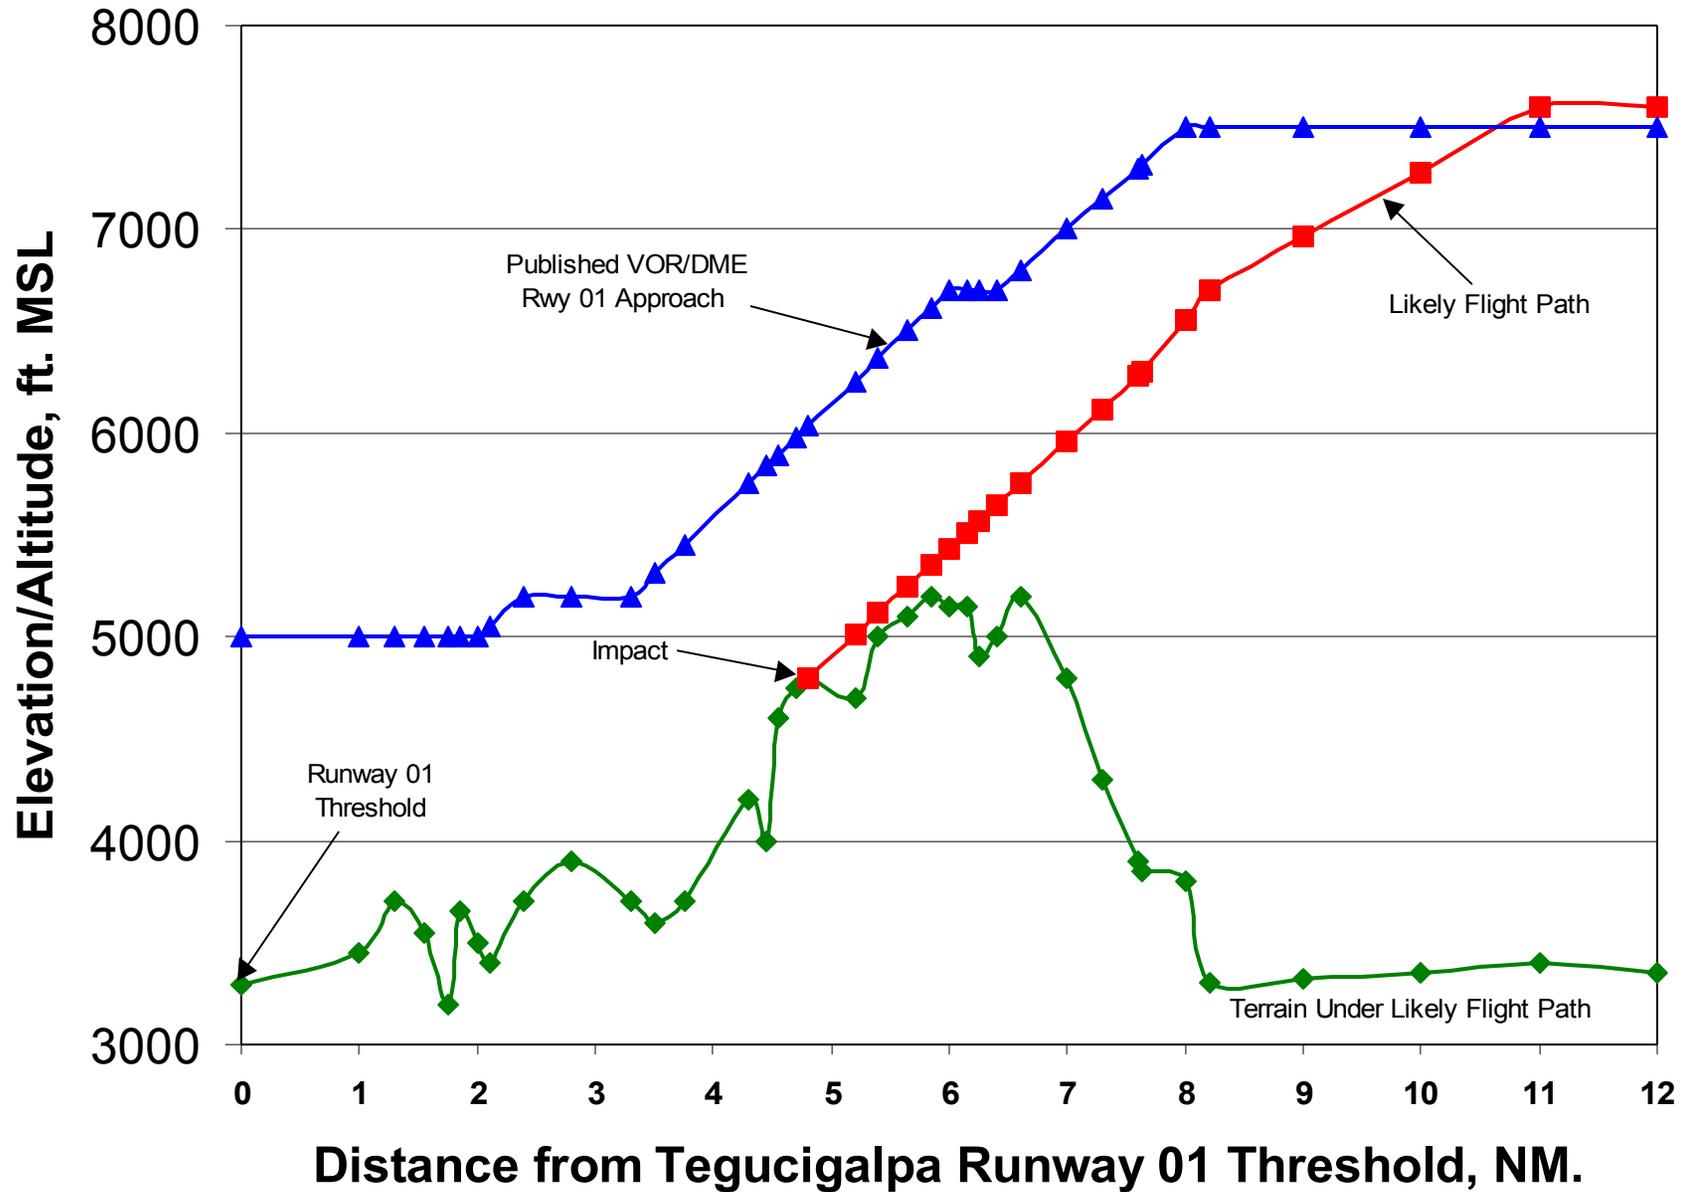
Figure 5.
Tegucigalpa, Honduras -- B-727-200 -- N88705 -- 10/21/89

SAHSA-414 was cleared by Tegucigalpa ATC for the VOR/DME Runway 01 approach, which includes a series of three step-downs from the initial approach fix altitude of 7500' MSL to avoid high terrain in the neighborhood of the airport. Rather than following the prescribed step-down procedure, however, the crew began a continuous descent from about 7600' MSL at about 11 NM from the airport to the accident site. The aircraft's descent profile was well below the published step-down course for the entire approach. (15)

N88705 was equipped with FDR, CVR and GPWS. However, because Honduran law did not require installation, the GPWS had been disconnected at the time of the accident. Table 6 presents altitude and elevation information for this accident. This information is presented graphically in Figure 5.

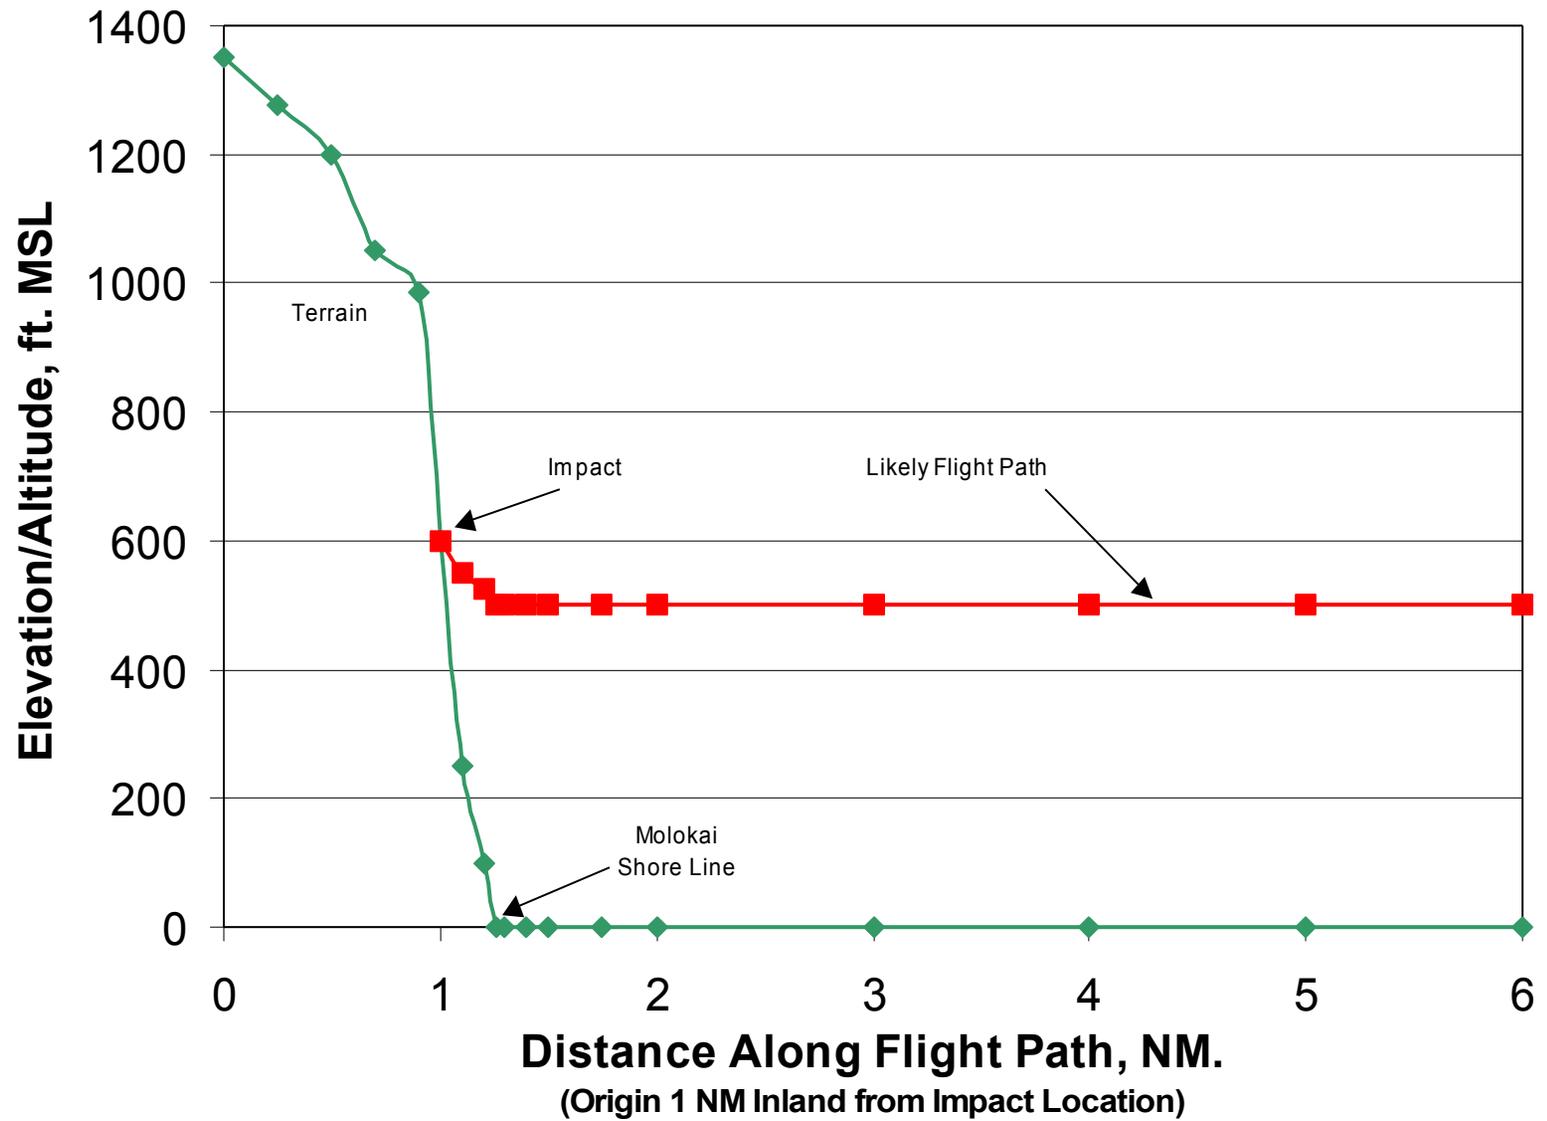
Figure 6.
Halawa Point, HI -- DHC-6-300 -- N707PV -- 10/28/89

Radar plots of flight 1712 show that it climbed to an altitude of about 1000' MSL following takeoff, then descended to 500' MSL at a point about five miles from the Molokai coast. It is likely the aircraft encountered the localized weather at this point and descended below the cloud ceiling to maintain visual contact with the terrain as is required under visual flight rules. At a point about two miles southeast of Halawa Point, the aircraft turned on a heading of 260° magnetic. The crew made this turn intending to fly their regular route parallel to and just offshore from the north coast of Molokai. However, because of limited visibility, they made this turn prematurely, heading the aircraft directly towards very steep terrain on Halawa Point. Lacking visual references, they were unable to see the terrain ahead until it was too late. (16)

N707PV not equipped with FDR, CVR or GPWS. Table 7 presents altitude and elevation information for this accident. This information is presented graphically in Figure 6.

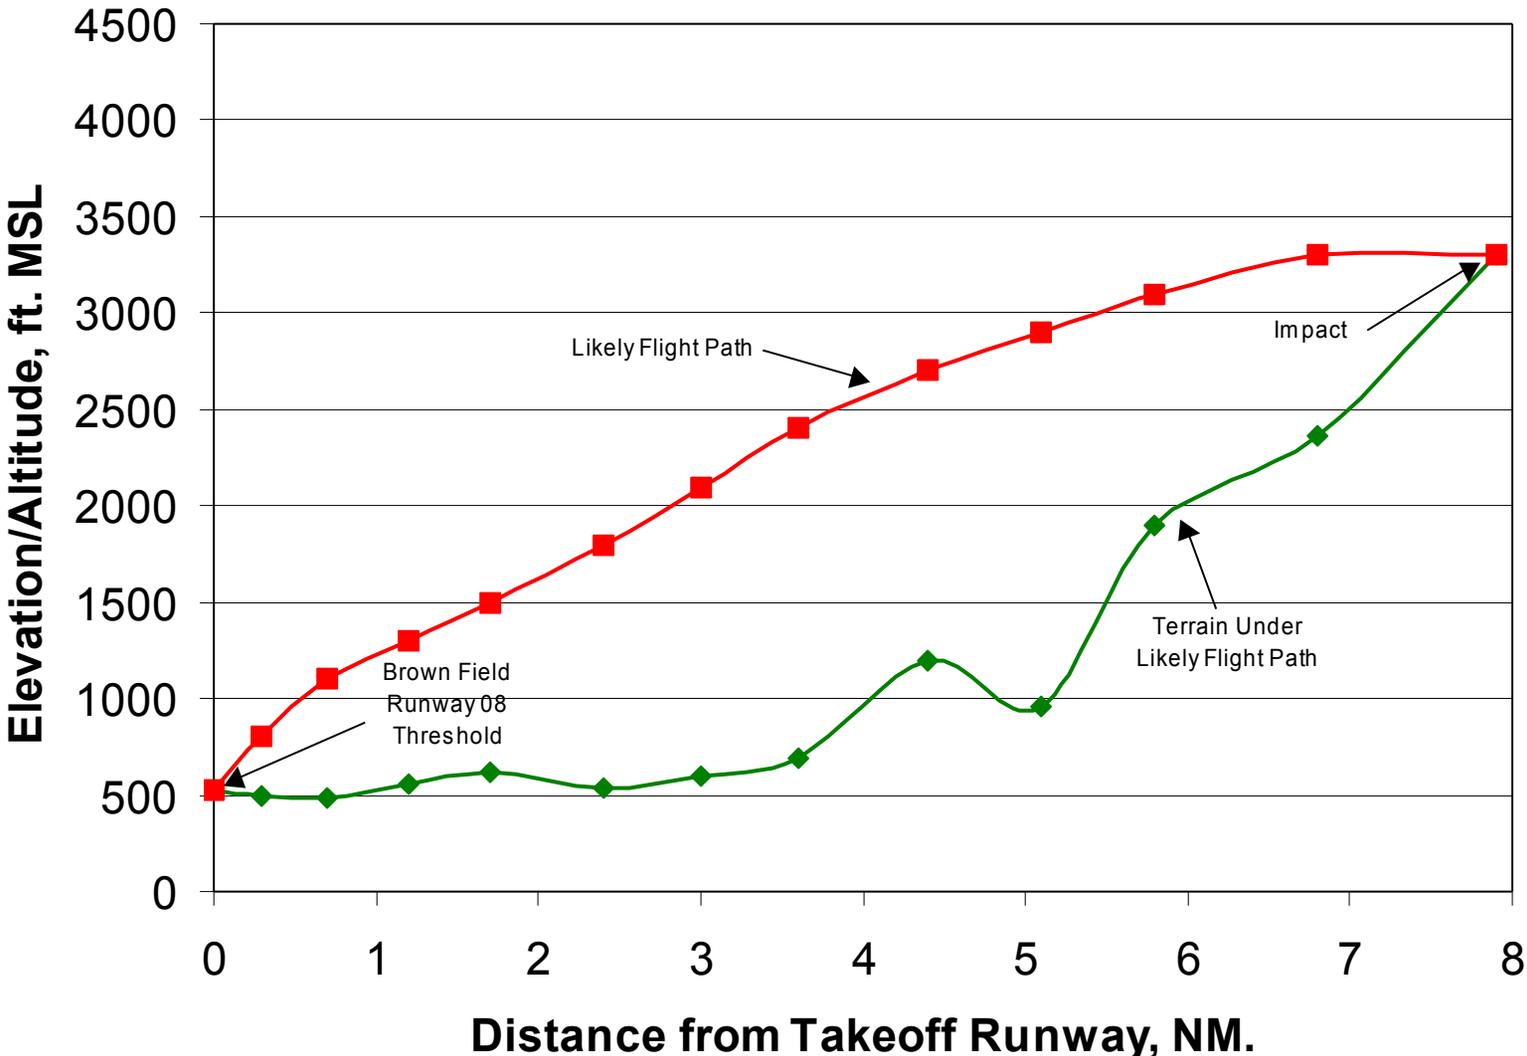
Because a late night departure was planned, the aircraft had been positioned at Brown Field on the outskirts of San Diego due to a noise curfew in effect at San Diego-Lindbergh field. While waiting for his passengers to arrive, the pilot, who was unfamiliar with local procedures and terrain, had three separate conversations with the local Flight Service Station (FSS). During these conversations, the FSS specialist suggested it would save time if the flight departed under visual flight rules and picked up its IFR clearance once airborne. The pilot indicated reluctance to climb through 3000' MSL without an IFR clearance, as that would involve flight into the San Diego Terminal Control Area (TCA) whose "floor" was 3000' MSL. The pilot then stated: "... so I would be better off if I headed right northeast and stayed down ... below three thousand." The FSS specialist replied "That'll be fine." This was a fatal mis-communication: the pilot had been referencing 3000' MSL, while the FSS specialist understood the pilot's altitude reference as 3000' above ground level. (17)

Radar data indicate the flight took off normally and leveled off at approximately 3300' MSL. The pilot had filed an IFR flight plan, but due to a delay in takeoff, this flight plan had expired. Without IFR clearance, the flight could not climb into the San Diego TCA without violating flight rules. Responding to the pilot's request for IFR clearance, the San Diego TRACON controller indicated N831LC's flight plan had "clocked out" but that he would "put it right back in." Shortly afterward, the aircraft impacted Otay Mountain. Because terrain in this location is uninhabited and unlit, the crew of N831LC did not see the mountain until it was too late to avoid impact. (18)

N831LC not equipped with FDR, CVR or GPWS. Table 8 presents altitude and elevation information for this accident. This information is presented graphically in Figure 7.

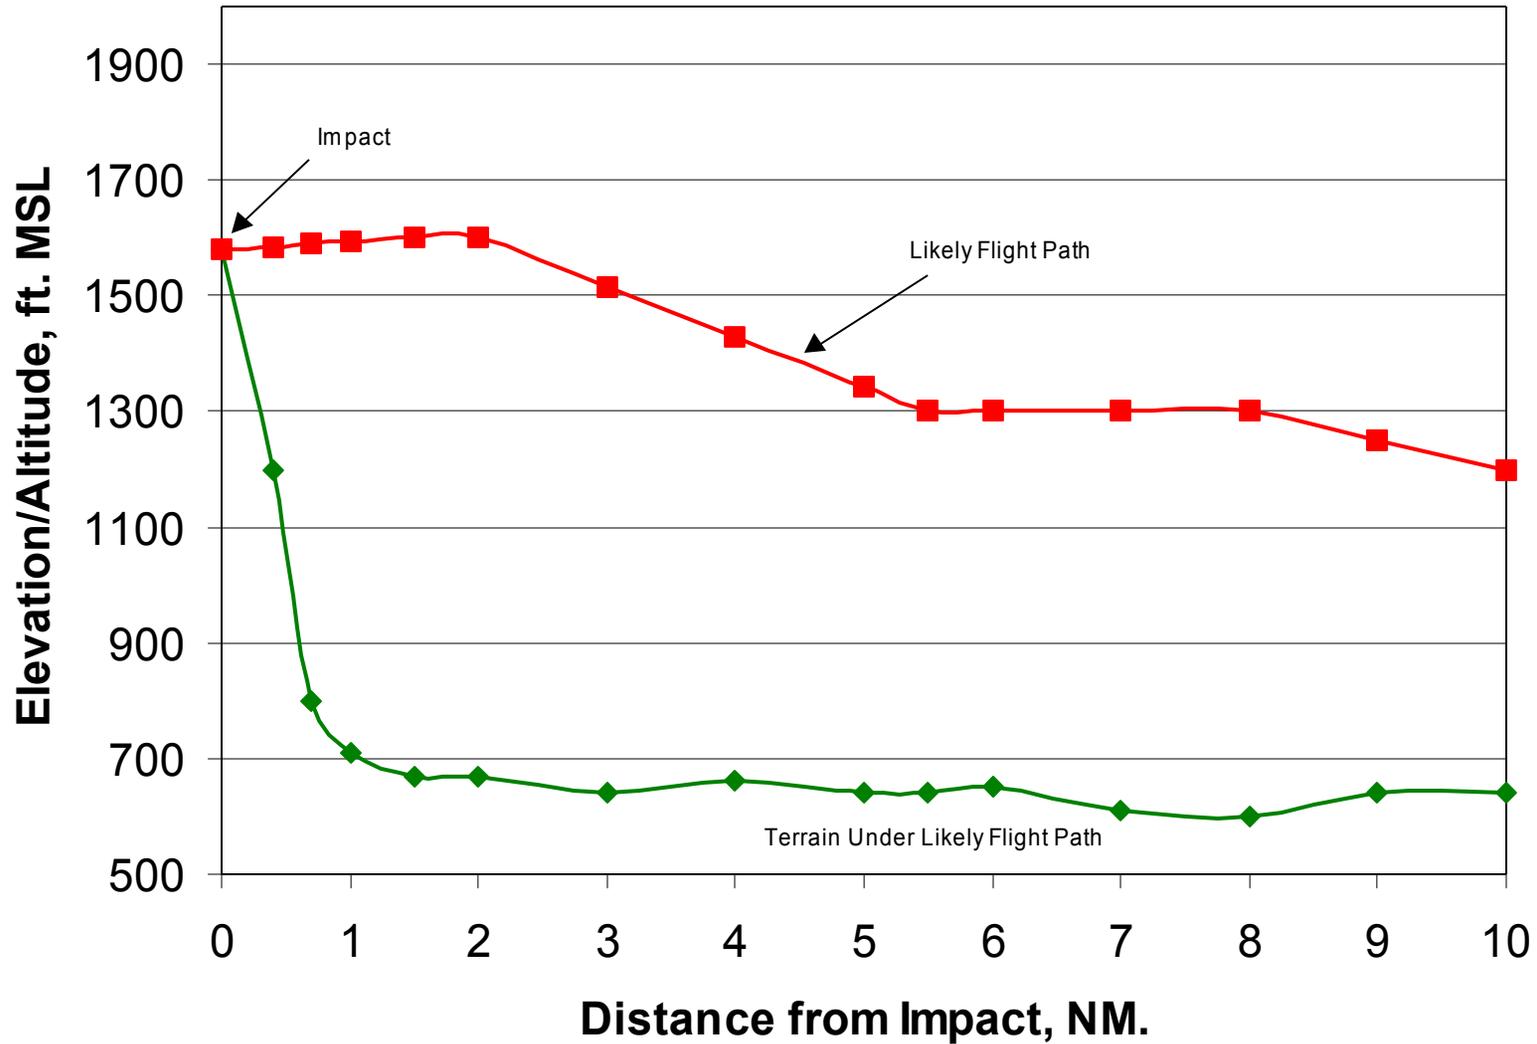
Figure 8.

The Rome accident involved a Beechcraft Be-400 turbojet owned by Bruno's, Inc., a regional grocery store chain, on a business flight from Rome to Huntsville, AL. The aircraft impacted Lavender Mountain, the highest terrain within a 5 NM radius of the airport, shortly after takeoff. Impact occurred at the 1580' MSL level, approximately 120' below the summit, on a heading of 025° magnetic. The aircraft was in cruise configuration. All nine persons aboard were killed. Weather in the accident vicinity was classified as daylight, IMC. The cloud ceiling obscured the tops of the mountains in the area.

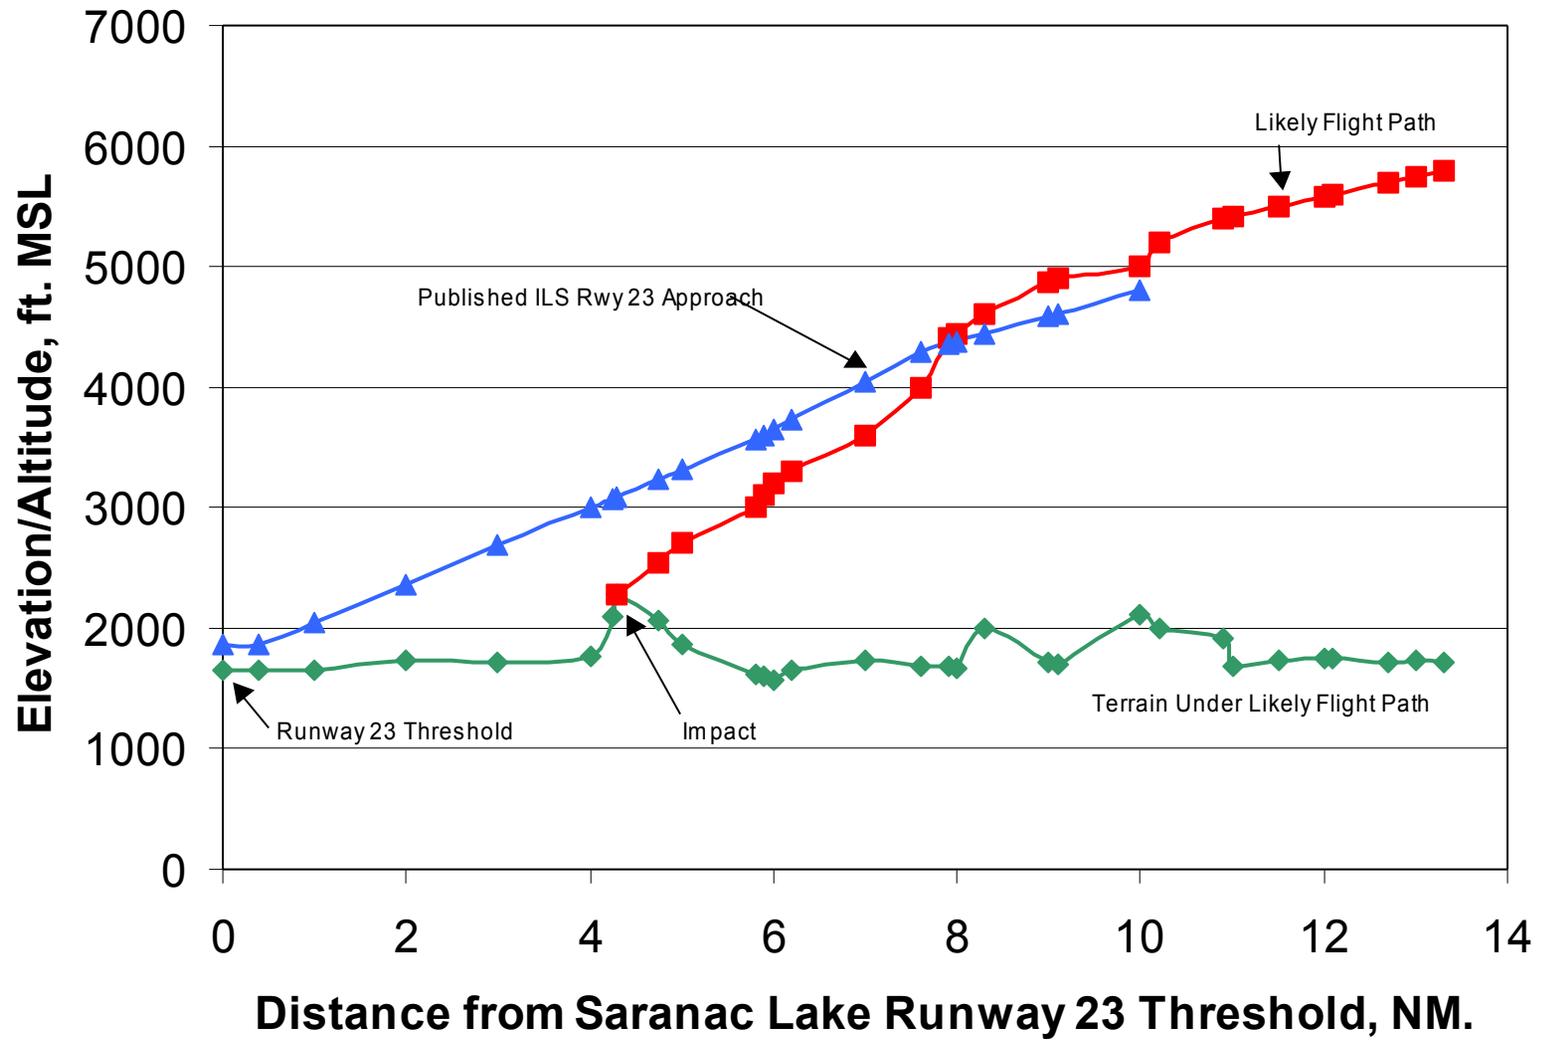
Figure 9.
Gabriels, NY -- Be-1900C -- N55000 -- 1/3/92

The Gabriels accident involved Commutair Flight 4821, a Beechcraft Be-1900C turboprop, on a regularly scheduled FAR Part 135 commuter flight between Plattsburgh, NY, and Saranac Lake, NY. The aircraft impacted Blue Hill, approximately 4.3 NM from the destination airport, at the 2280' MSL elevation, about 110' below the summit, on a heading of 230° magnetic, on course for runway 23 at Saranac Lake. Four persons were on board; two were killed and two suffered serious injuries. At impact, gear and flaps were retracted. Weather in the accident vicinity was classified as dark night, IMC.

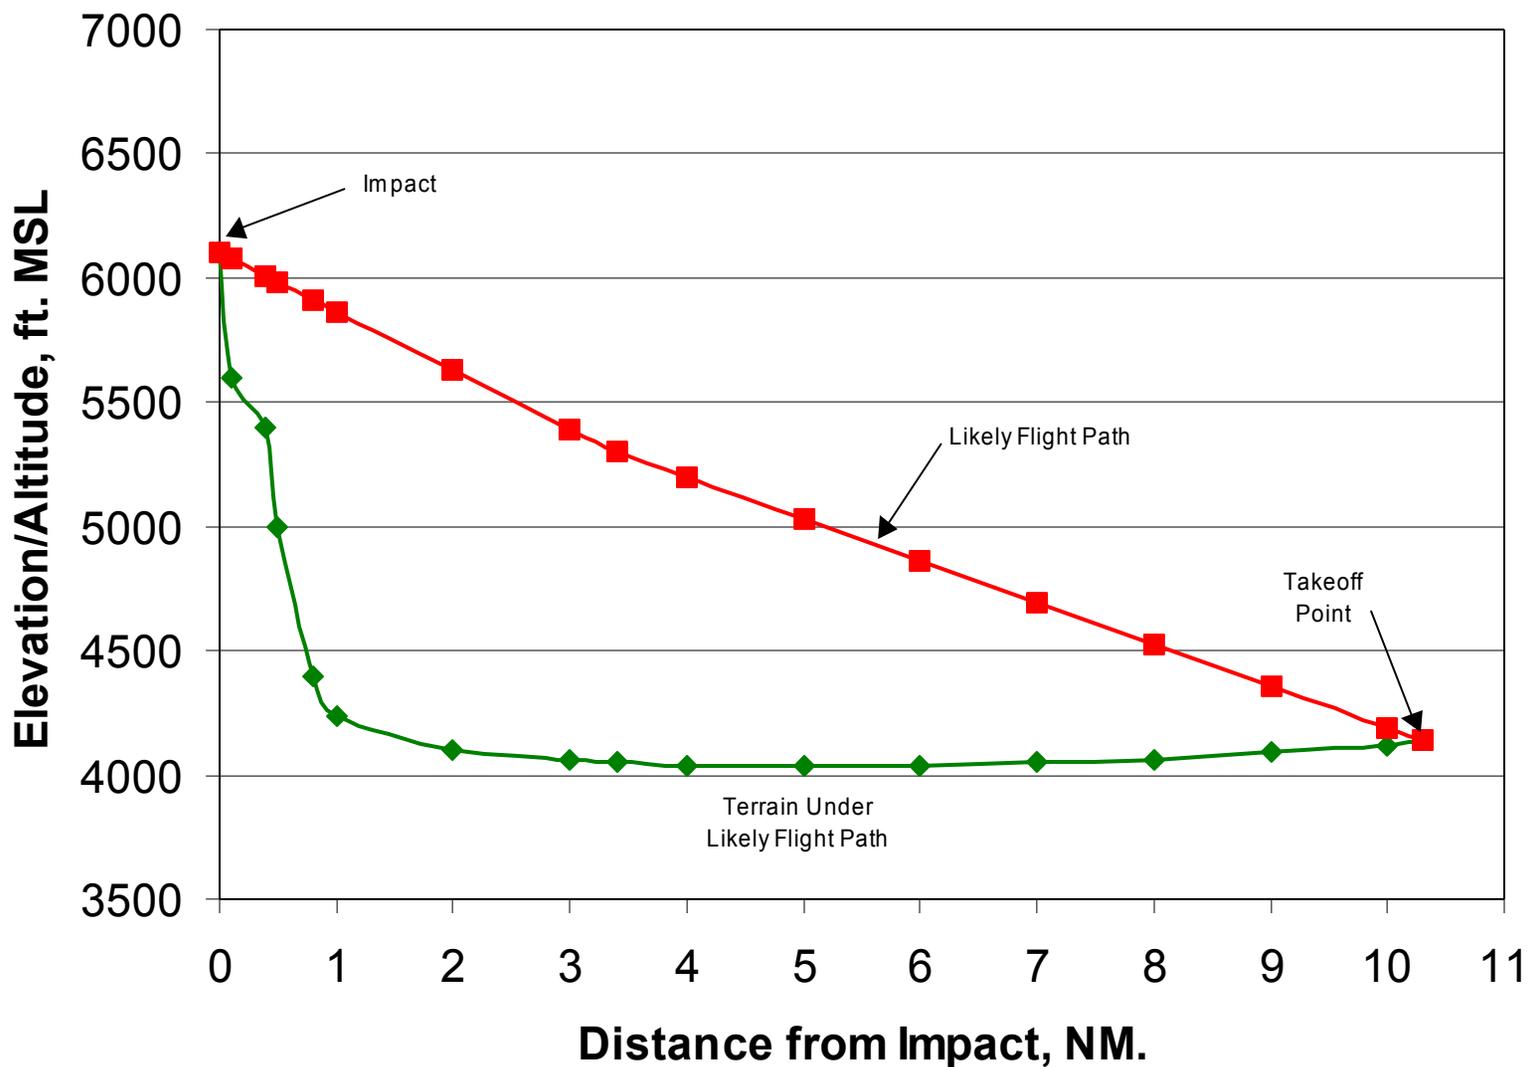
Figure 10.

The Alamogordo accident involved a privately owned Mitsubishi MU-2B-30 turboprop on a personal FAR Part 91 flight from Alamogordo to Burnet, TX. Shortly after takeoff, the aircraft impacted a ridge in the Sacramento Mountains to the east of Alamogordo at the 6100' MSL level, approximately 1500' below the summit, on a heading of 035° magnetic. The aircraft was in cruise configuration; all six persons aboard were killed. Weather in the accident vicinity was classified as dark night, VMC.

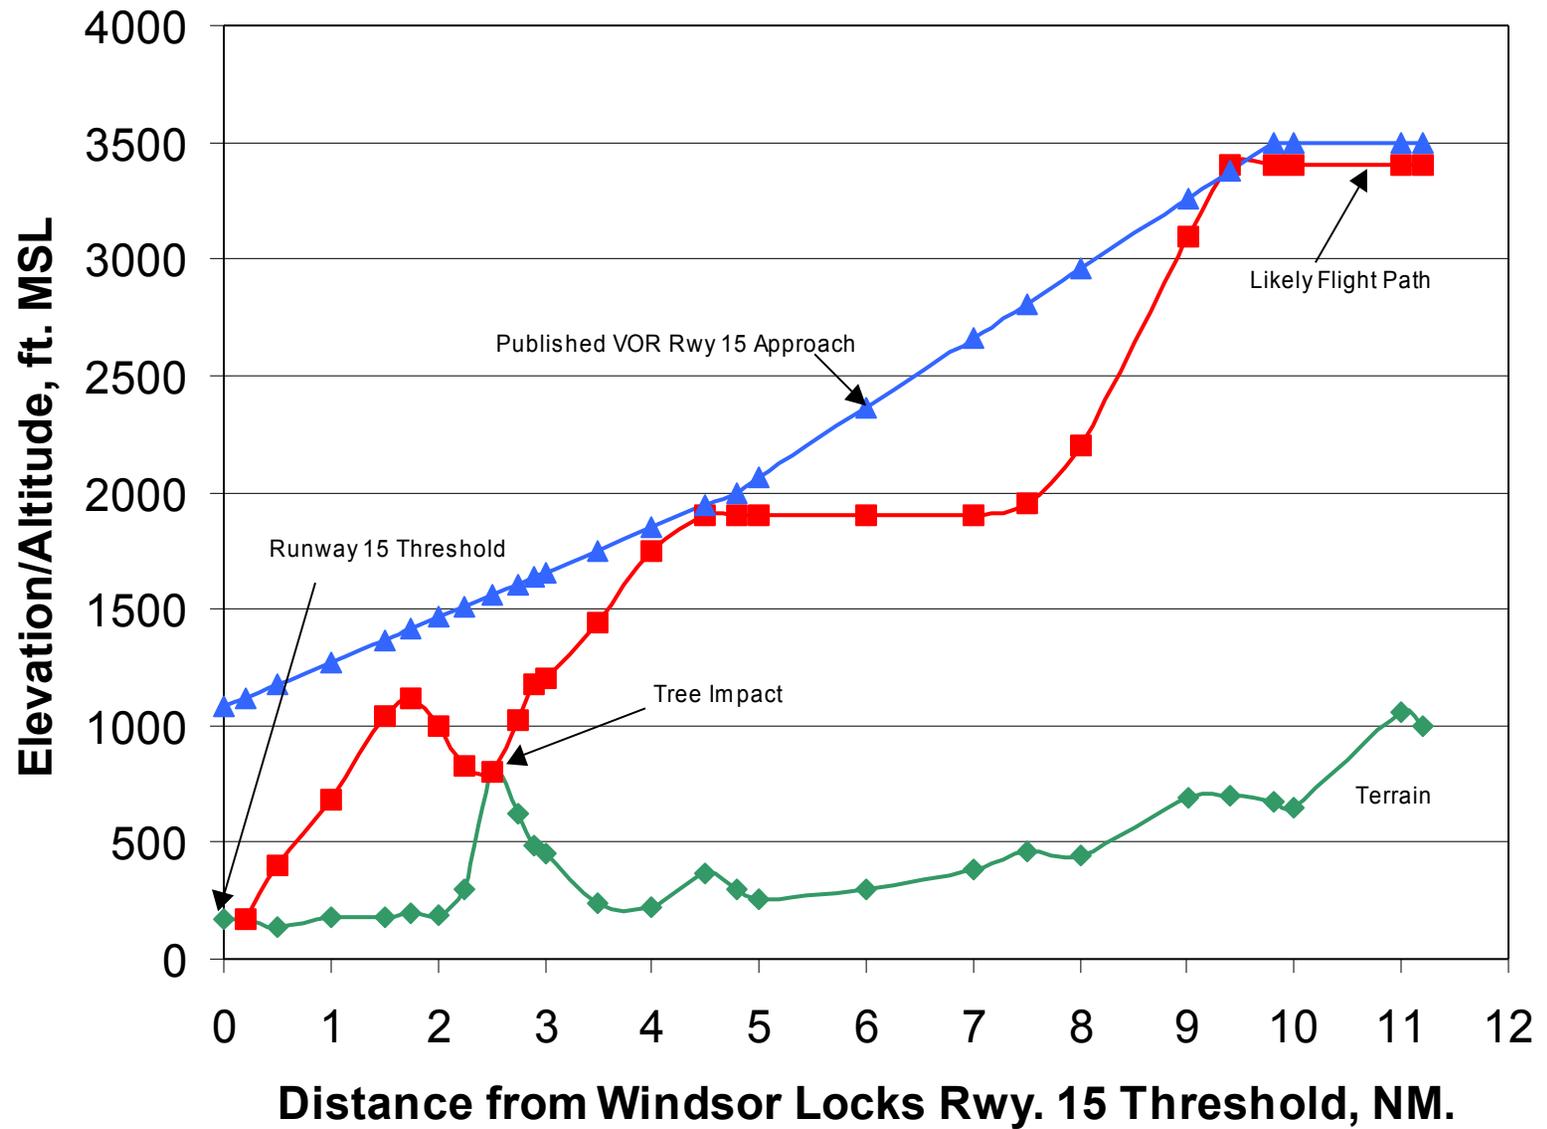
Figure 11.
East Granby, CT -- MD-83 -- N566AA -- 11/12/95

The East Granby accident involved American Airlines flight 1572, a McDonnell-Douglas MD-83 turbojet on a regularly-scheduled FAR Part 121 flight from Chicago, IL to Hartford-Bradley Field, Windsor Locks, CT. On a VOR approach to Runway 15 at Windsor Locks, the aircraft impacted trees on the summit of a ridgeline approximately 2.5 NM northwest of the runway threshold. Impact occurred on a heading of 149° magnetic, on course for Runway 15. Although one of its engines failed and the other engine and control surfaces were damaged, the crew managed to keep the aircraft airborne and made an emergency landing in the safety overrun area for Runway 33 (the opposite end of Runway 15), destroying an antenna array in the process. Because the crew was able to land the aircraft safely, only one passenger suffered minor injuries in the emergency evacuation process which commenced once flight 1572 had come to a stop. Weather in the accident vicinity was classified as dark night, IMC, and was a strong contributing factor. An extremely powerful cold front was passing through the area at the time, and atmospheric pressure was dropping rapidly, with high winds, windshear and heavy rain. Post-crash investigation showed the pilots had not received an updated weather briefing and had not set their altimeter to the correct barometric pressure reading at the time of the accident, which caused their altimeter to give falsely high readings. (23)
